Project Name: Anaconda Aluminum Company		Site Location: Columbia Falls Aluminum Company Site, Flathead County, Montana	TDD No: 0004/1305-04
Photo No. 1	Date: 6/3/2013

PHOTOGRAPH LOG

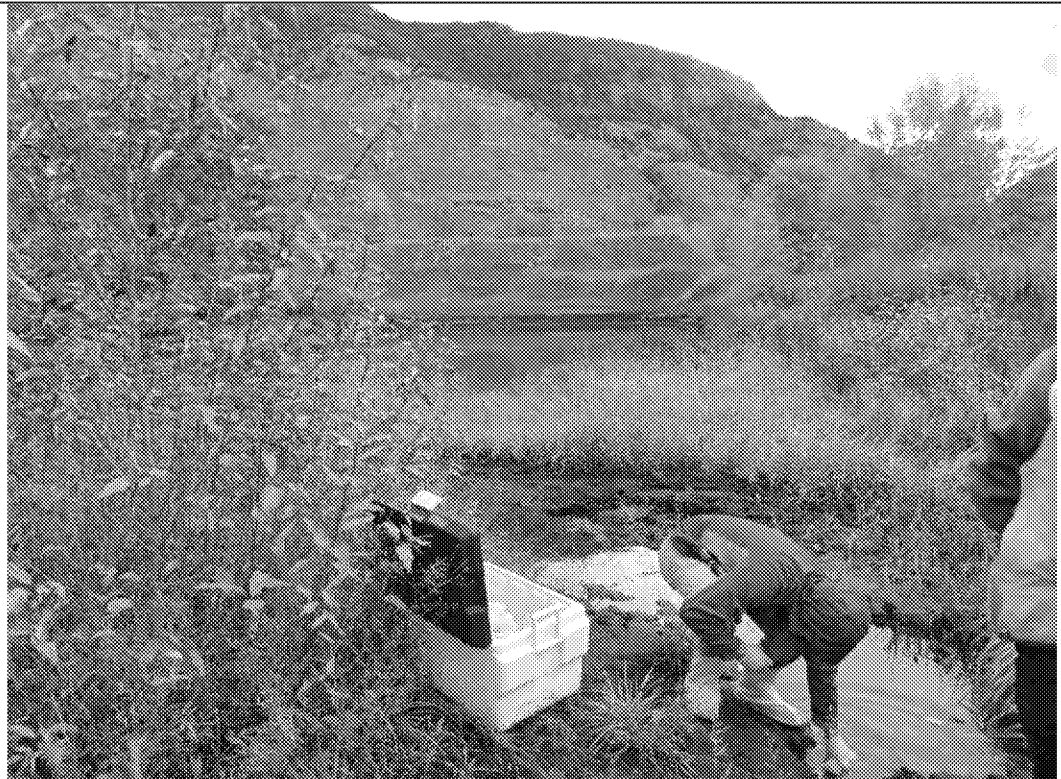
Photo No. 36	Date: 9/30/2013

Direction Photo Taken: E		
Description: Showing location for co-located waste source / surface water sample: CF-WS / SW-19.

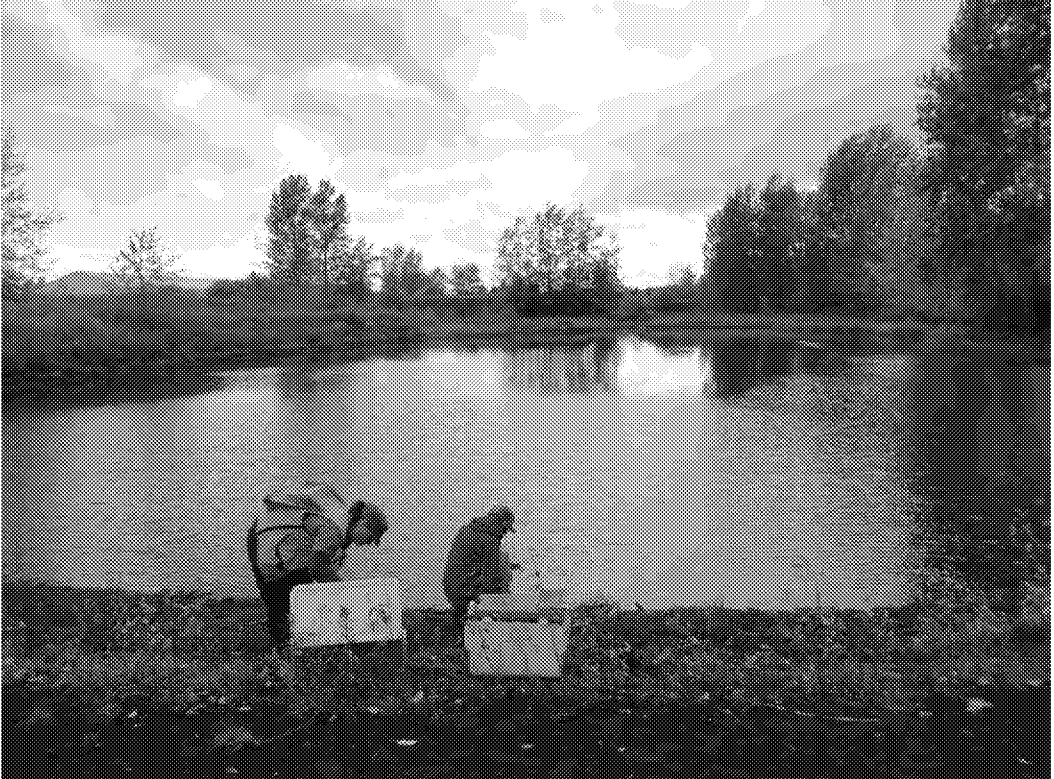
Project Name: Anaconda Aluminum Company		Site Location: Columbia Falls Aluminum Company Site, Flathead County, Montana	TDD No: 0004/1305-04
Photo No. 37	Date: 9/30/2013

Direction Photo Taken: W			
Description: Showing location for co-located waste source / surface water sample: CF-WS / SW-20.

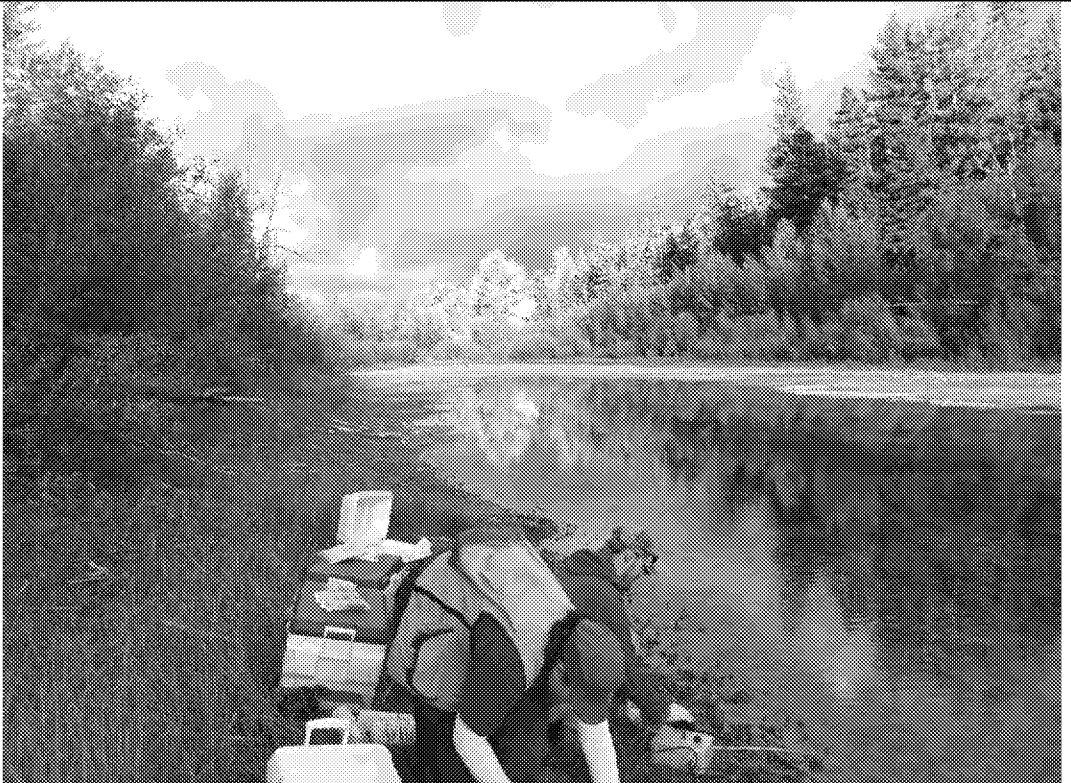
Project Name: Anaconda Aluminum Company		Site Location: Columbia Falls Aluminum Company Site, Flathead County, Montana	TDD No: 0004/1305-04
Photo No. 39	Date: 10/1/2013

Direction Photo Taken: W			
Description: Showing location for co-located waste source / surface water sample: CF-WS / SW-22.

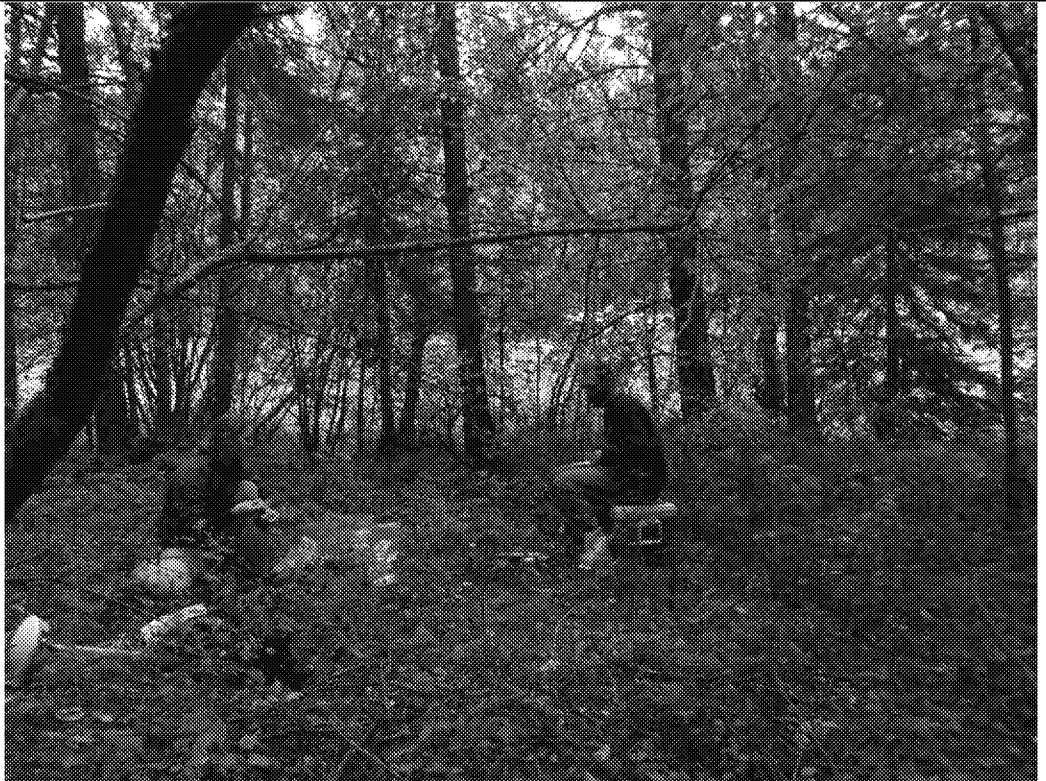
Project Name: Anaconda Aluminum Company		Site Location: Columbia Falls Aluminum Company Site, Flathead County, Montana	TDD No: 0004/1305-04
Photo No. 41	Date: 9/27/2013

Direction Photo Taken: E			
Description: Showing location for soil sample: CF-SS-02.

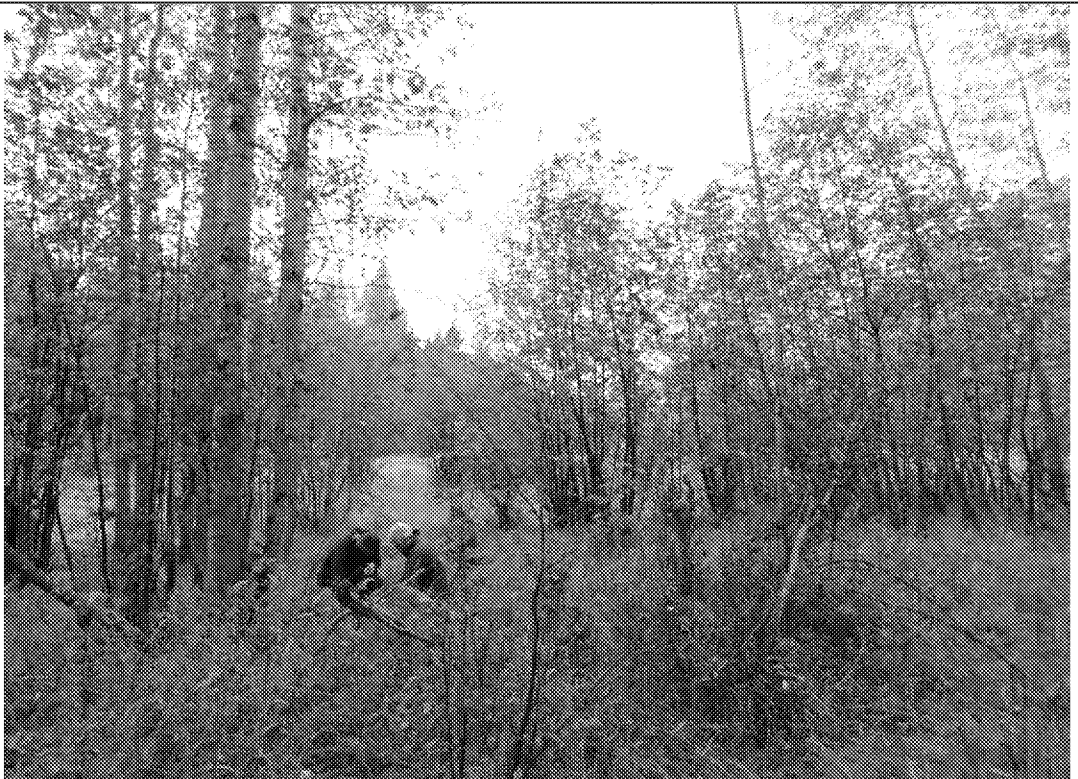
Photo No. 42	Date: 9/27/2013

Direction Photo Taken: SE		
Description: Showing location for soil sample: CF-SS-03.

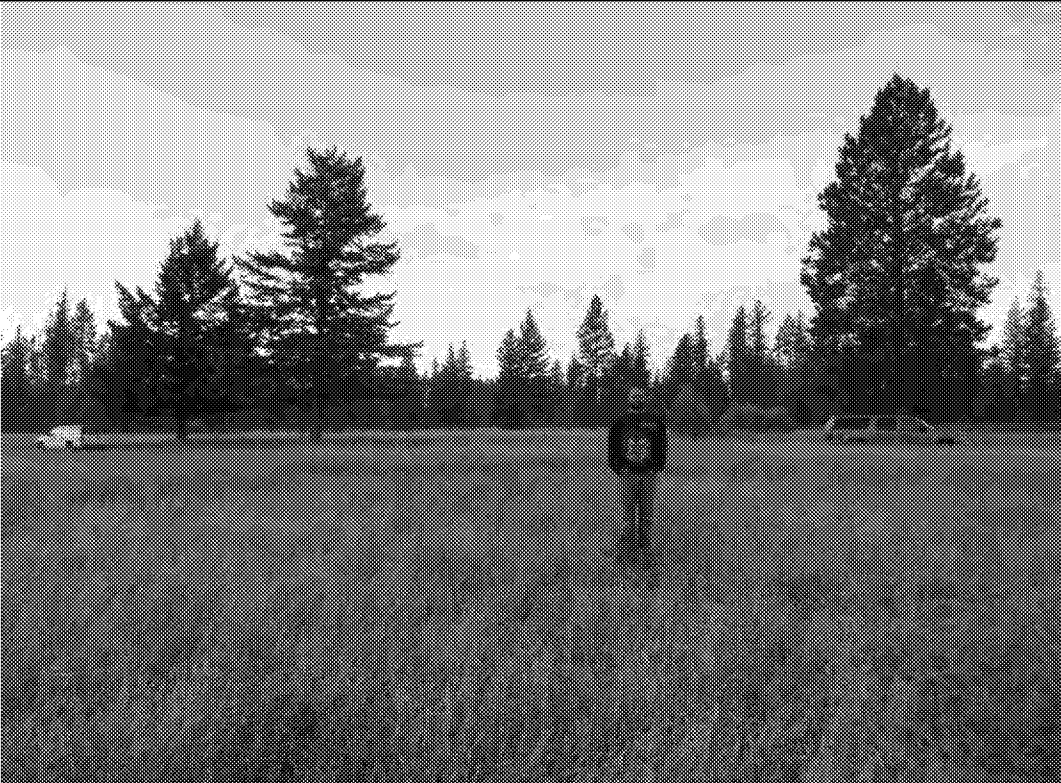
Project Name: Anaconda Aluminum Company		Site Location: Columbia Falls Aluminum Company Site, Flathead County, Montana	TDD No: 0004/1305-04
Photo No. 43	Date: 9/27/2013

Direction Photo Taken: W			
Description: Showing location for soil sample: CF-SS-04.

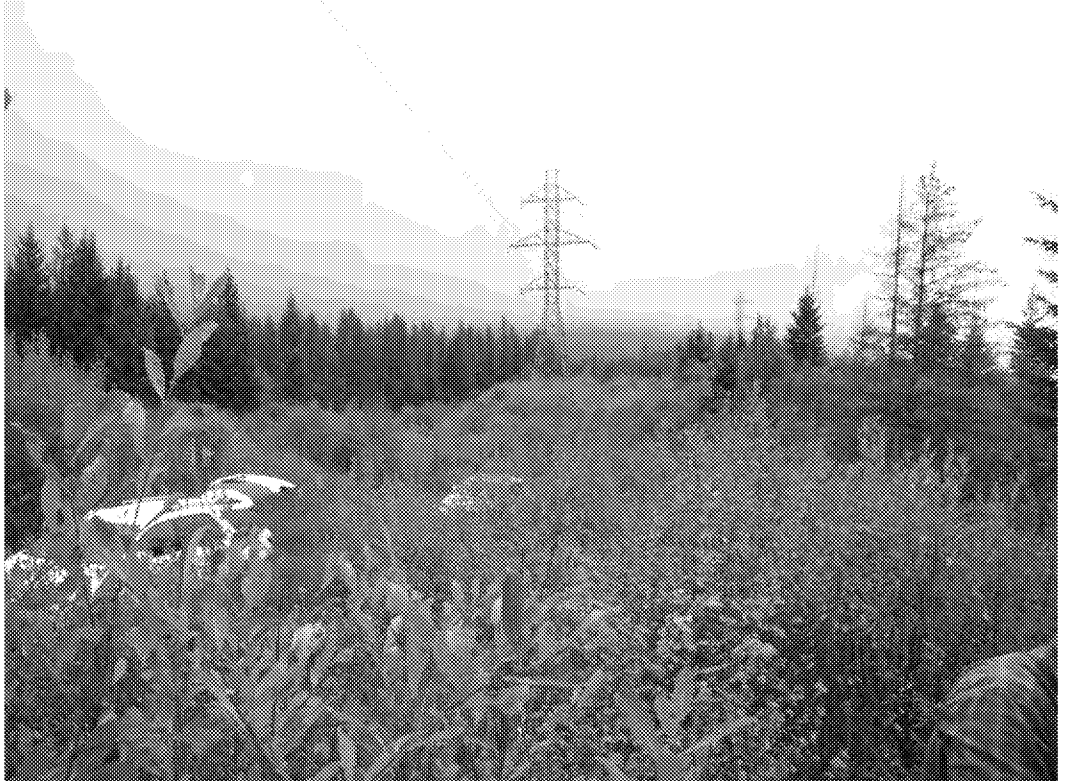
Project Name: Anaconda Aluminum Company		Site Location: Columbia Falls Aluminum Company Site, Flathead County, Montana	TDD No: 0004/1305-04
Photo No. 45	Date: 9/24/2013

Direction Photo Taken: S			
Description: Showing location for soil sample: CF-SS-06.

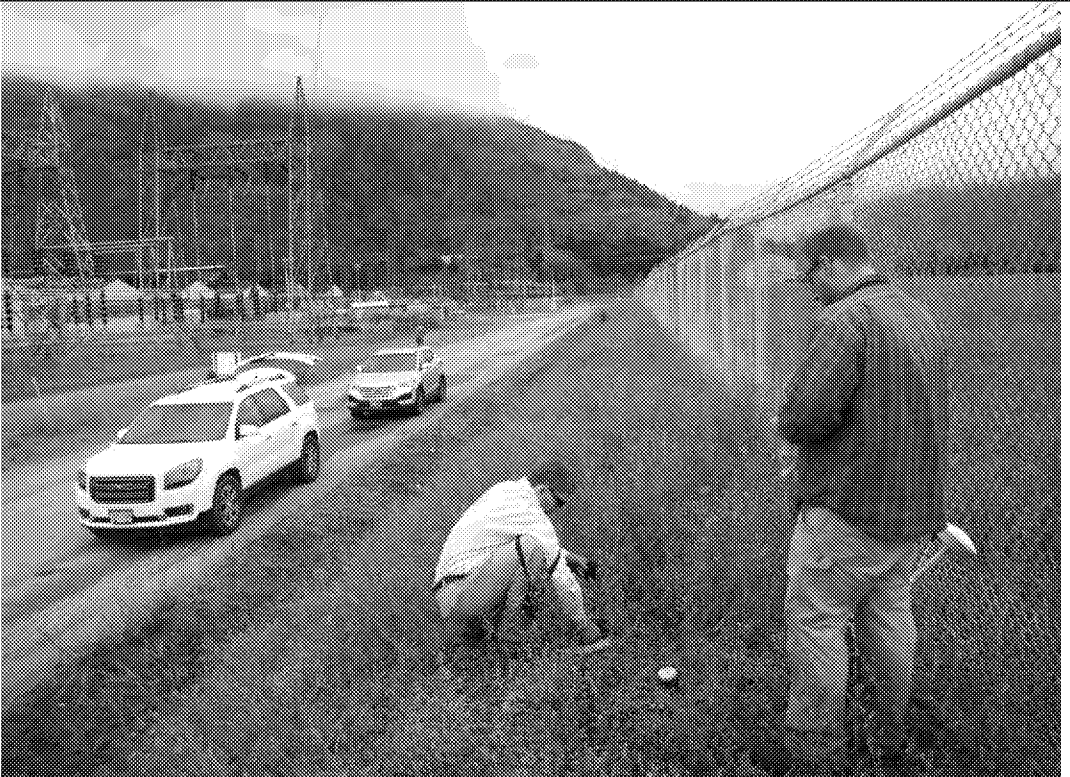
Photo No. 46	Date: 9/24/2013

Direction Photo Taken: E		
Description: Showing location for soil sample: CF-SS-07.

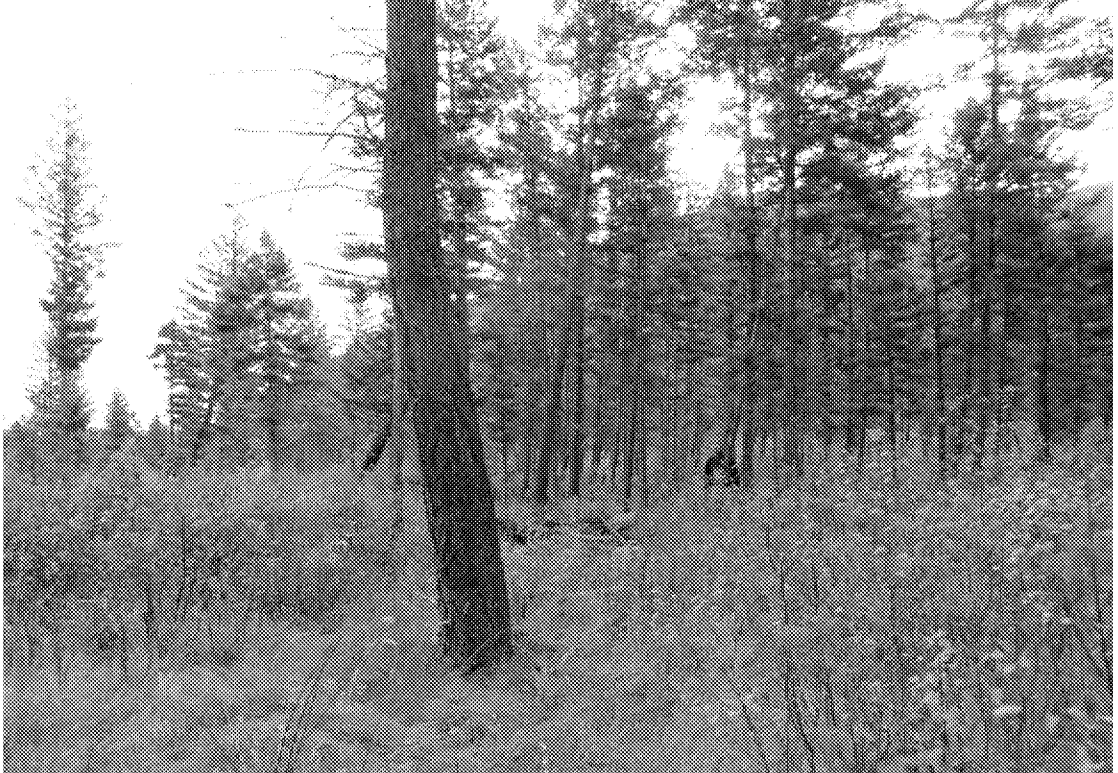
Project Name: Anaconda Aluminum Company		Site Location: Columbia Falls Aluminum Company Site, Flathead County, Montana	TDD No: 0004/1305-04
Photo No. 47	Date: 9/27/2013

Direction Photo Taken: SE			
Description: Showing location for soil sample: CF-SS-08.

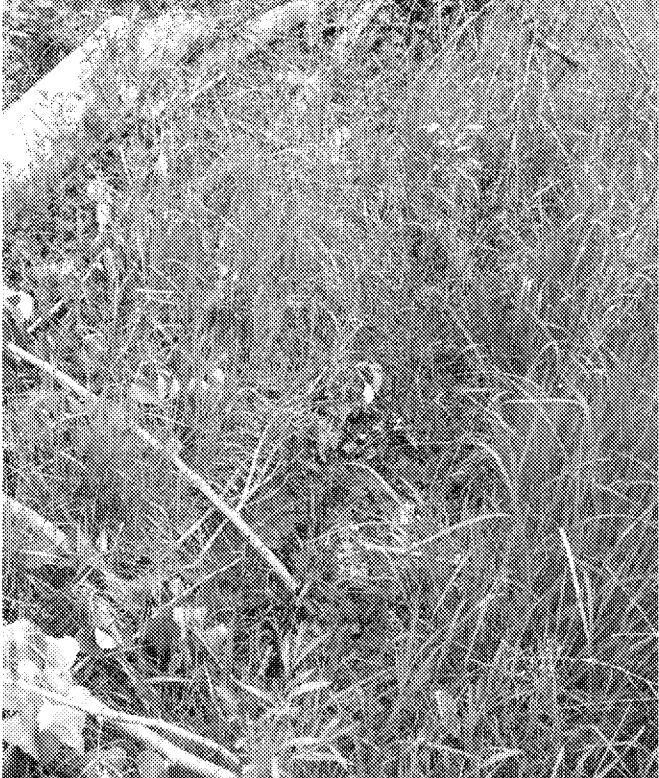
Project Name: Anaconda Aluminum Company		Site Location: Columbia Falls Aluminum Company Site, Flathead County, Montana	TDD No: 0004/1305-04
Photo No. 49	Date: 6/3/2013

Direction Photo Taken: Down			
Description: Showing seep of Outfall D006 location.
